Manhole Inspection Summary

Manhole # S45I2_007MH

Insp Date: **1/7/08 7:36 AM**

Location Address: **1401 Elmtree St**

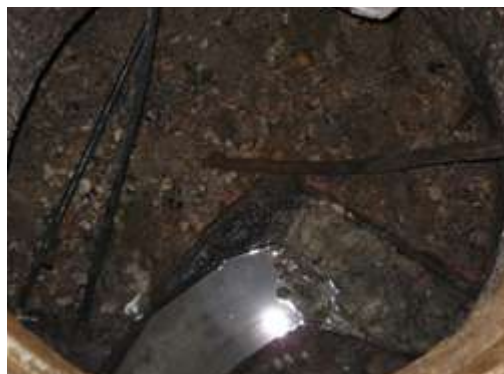
Defect 1

Condition: ☐ Sound ☐ Cracked ☐ Root Intrusion ☐ Deteriorated ☐ Leaks ☒ **Debris**

Bench/channel

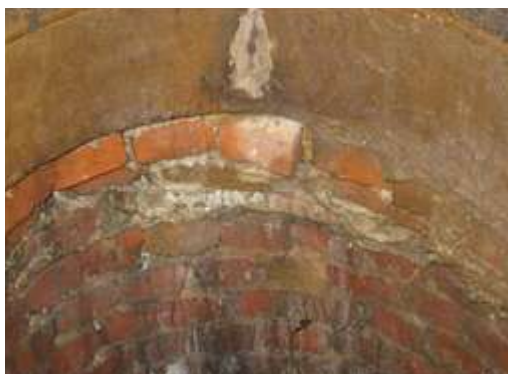
Defect 2

Condition: ☐ Sound ☐ Cracked ☐ Root Intrusion ☒ **Loose Brick** ☐ Deteriorated

Infiltration: ☐ None ☐ Joint ☐ Cracks ☒ **Mortar** ☐ Roots ☒ **Wall**

Infiltration

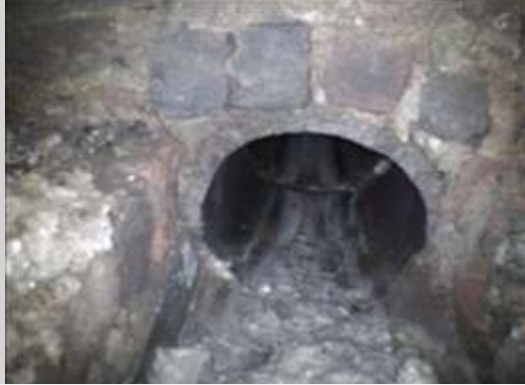
12 O'Clock Outflow

8 in. Circular Gravity Sewer
Pipe Out @ 12 O'Clock

Pipe Height: **8.4** (in.) Rod and Bar (Angled)
Pipe Material: **Clay** ☐ Pipe Lined
Invert Depth: **7.75** (ft.) Flow Characteristics: **Fast**
Deposits: ☐ None ☐ Mud ☐ Sludge ☒ **Debris** ☐ Grease
Silt Depth: **0** (in.) Deposits Extent: **Light**
Infiltration: **None** Pipe Seal Cond: **Sound**

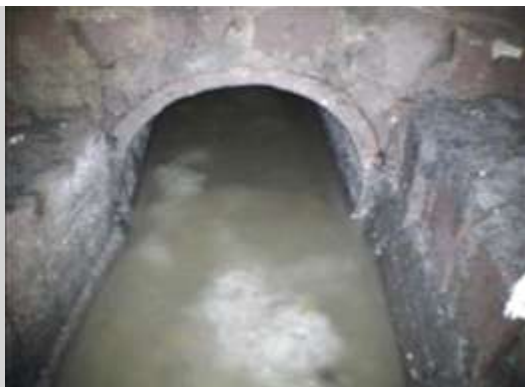
3 O'Clock Inflow

8 in. Circular Service Sewer
Pipe In @ 3 O'Clock

Pipe Height: **10.8** (in.) Rod and Bar (Angled)
Pipe Material: **Clay** ☐ Pipe Lined
Invert Depth: **7.63** (ft.) Flow Characteristics: **Slow**
Deposits: ☒ None ☐ Mud ☐ Sludge ☐ Debris ☐ Grease
Silt Depth: (in.) Deposits Extent:
Infiltration: **None** Pipe Seal Cond: **Sound**
